A 3.2 Case studies on wrecks filled with chemical munitions

Verification of risk assessment procedures for shipwrecks filled with ammunition

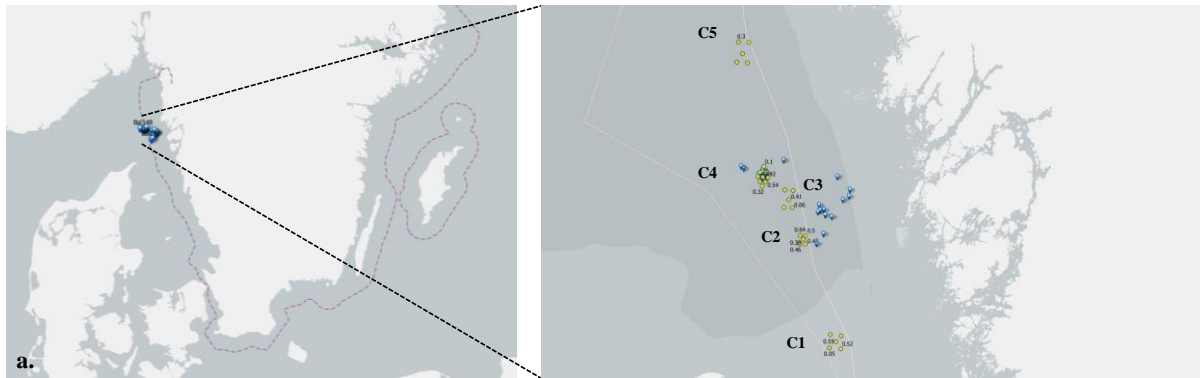
Figure 4 Displayed is the Måseskär CWA dump site (a, left) on the west coast of Sweden, and a magnified image of the dispersal of the 28 wrecks in the area and the sediment sampling points from the Chalmers study (right.) (Illustration taken from [11])

Another deep-water dumpsite was the Måseskär area (27 x 21 km, 259756, 6450499 [SWEREF 99]) (Figure 4a), where only unconfirmed information exists of if and how much CWAs was dumped after WWII. The area is a known good spot for commercial fishing where trawling is performed daily. Furthermore, the area has been investigated during a few expeditions over the years. In a more recent survey in 2015, the area was also thoroughly investigated during a hydrographic survey, using side scan sonar and multibeam echosounder, where 28 wrecks were detected. In addition, 13 of the wrecks were further investigated using a Remotely Operated Vehicle (ROV) [7].

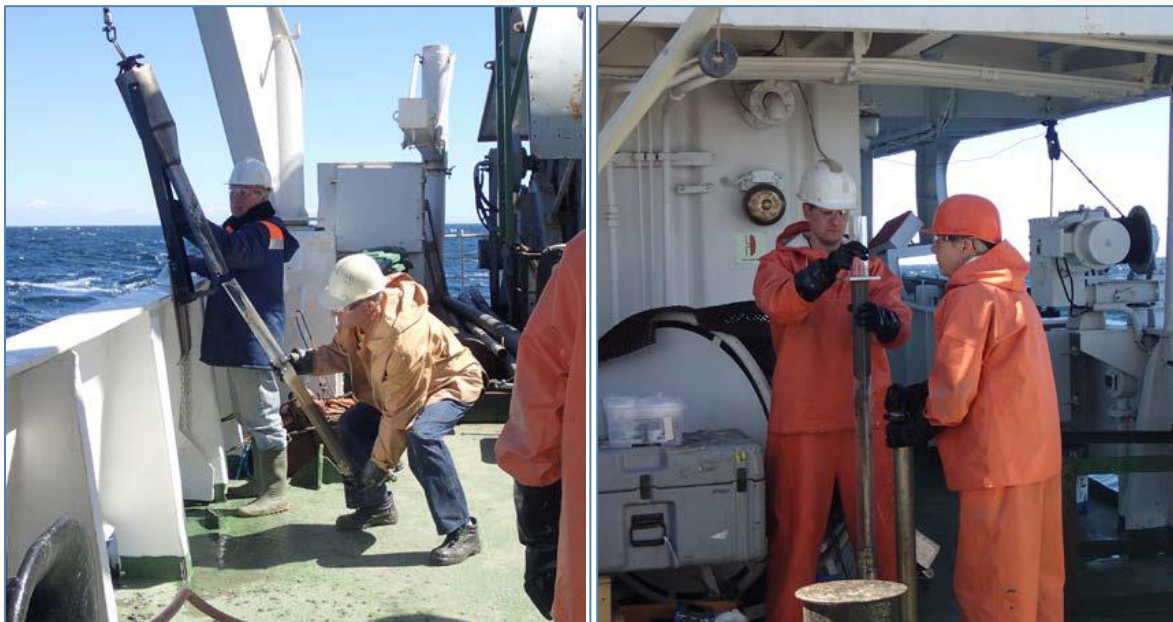
Figure 5 Sampling work on-board Akademik Strakhov in the Måseskär area in June 2017. A Niemesto corer from SIO was used to take virtually undisturbed sediment samples. These were later processed for Arsenic (analysed at CTH), for degradation products of chemical weapons (analysed at VERIFIN) and for meiofauna (analysed at IOPAN, Poland). (Picture from [10])

(downstream, 24-29 km to the closest wreck) and the last area was a control area south of Måseskär, 22-26 km from the closest ship wreck). At each area five sites were sampled for pore water and sediments, except for the area with highest concentration of wrecks (cluster 4), where 9 sites were sampled. At each site five sediment cores were taken and sliced at 0-3, 4-6, 7-10 and 11-15 cm (Figure 5). The sliced sediment samples from the five cores were then thoroughly homogenized and pooled, and the pooled samples were divided for analysis of CWA, total arsenic content and meiofaunal community composition. The collected sediment samples were analysed for arsenic by ALS Scandinavia. Sediment and pore-water samples were analysed for remains of chemical weapons by the Finnish Institute for Verification of the Chemical Weapons Convention (VERIFIN) and the meiofauna samples were counted and classified under microscope by the Institute of Oceanology (IOPAN) in Poland. In addition, samples were pre-screened for arsenic on-board using a fast X-Ray Fluorescence (XRF) technique.

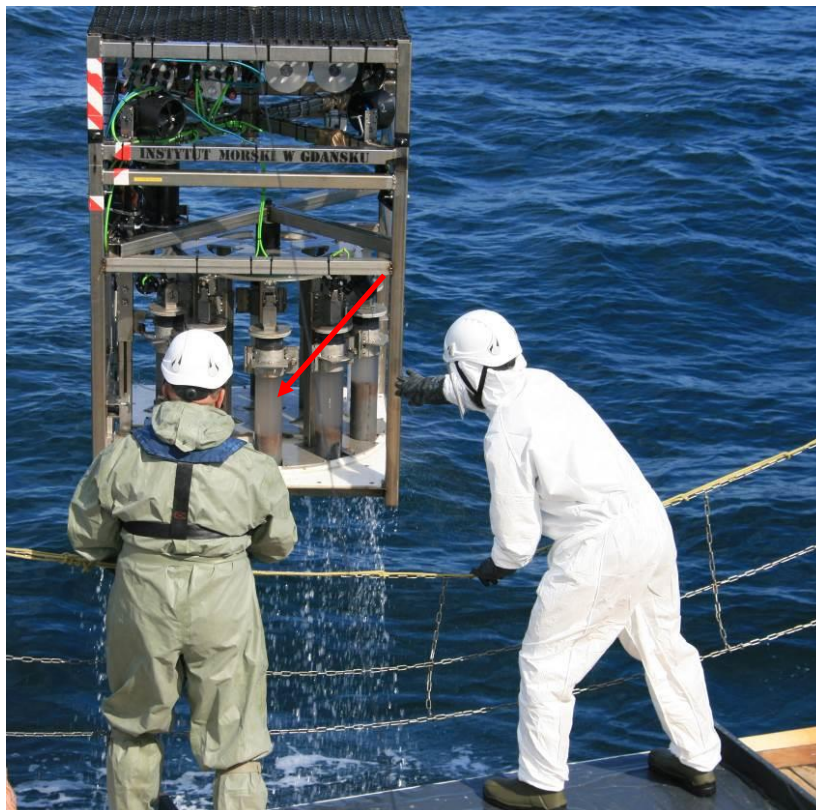
Figure 6 Multi-increment revolving sampler constructed at Maritime Institute Gdańsk. The sampler allows ten single sediment samples (red arrow) to be collected from the sea floor in one dive. (Photo: FFI)

Since the sea depth in the Skagerrak dumping area is between 550 m and 700 m, the time to collect one single sediment sample is considerable. In order to make the sampling more time-efficient, a multi-increment (revolving) sampler was constructed by the Maritime Institute in Gdańsk [16]. This sampler would make it possible to take ten single sediment samples (cores) before it is hoisted to the surface and emptied (Figure 6).

The sampler is a semi-autonomous system and is able to move around near the bottom using its own power supply and propulsion system. It also has mounted HD cameras and lightning for documentation of the sampling.

The sampler was tested in June 2017 close to Wreck no 13 in the Norwegian part of Skagerrak. Due to water leakage into the electronics and broken signal cables, only one dive resulting in the collection of eight sediment cores was performed.

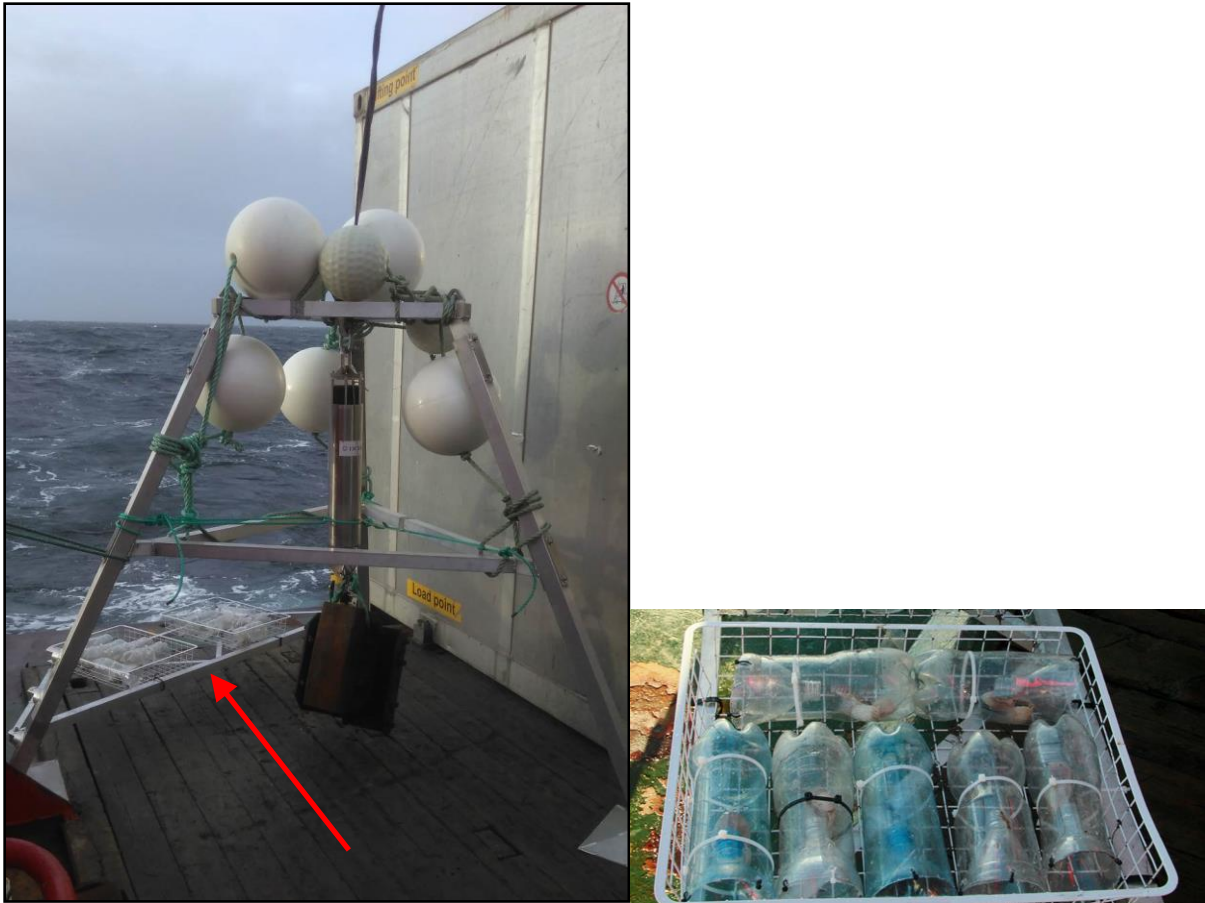
Figure 7 Rig with hagfish traps (red arrow) and soda bottles with fish used as bait. (Photo: FFI)

A rig with truncated soda bottles was used as hagfish trap (Figure 7). After approximately 12 hours, the traps were recovered (Figure 8) and the hagfish were dissected and prepared for transport back to the laboratories.

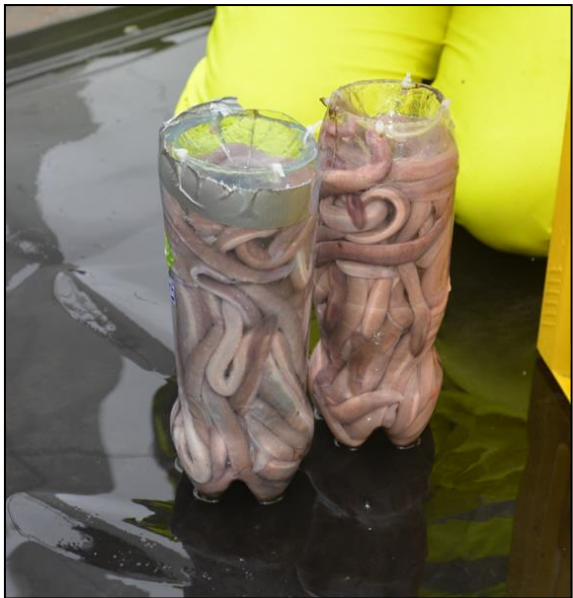
Figure 8 Soda bottles with catch of hagfish. (Photo: FFI)
