SMART FISH FARM, NORSKEHAVET - MILJØUNDERSØKELSER

Visuell kartlegging, 2021

MariCulture AS

Rapportnr.: 2021-4041, Rev. 0

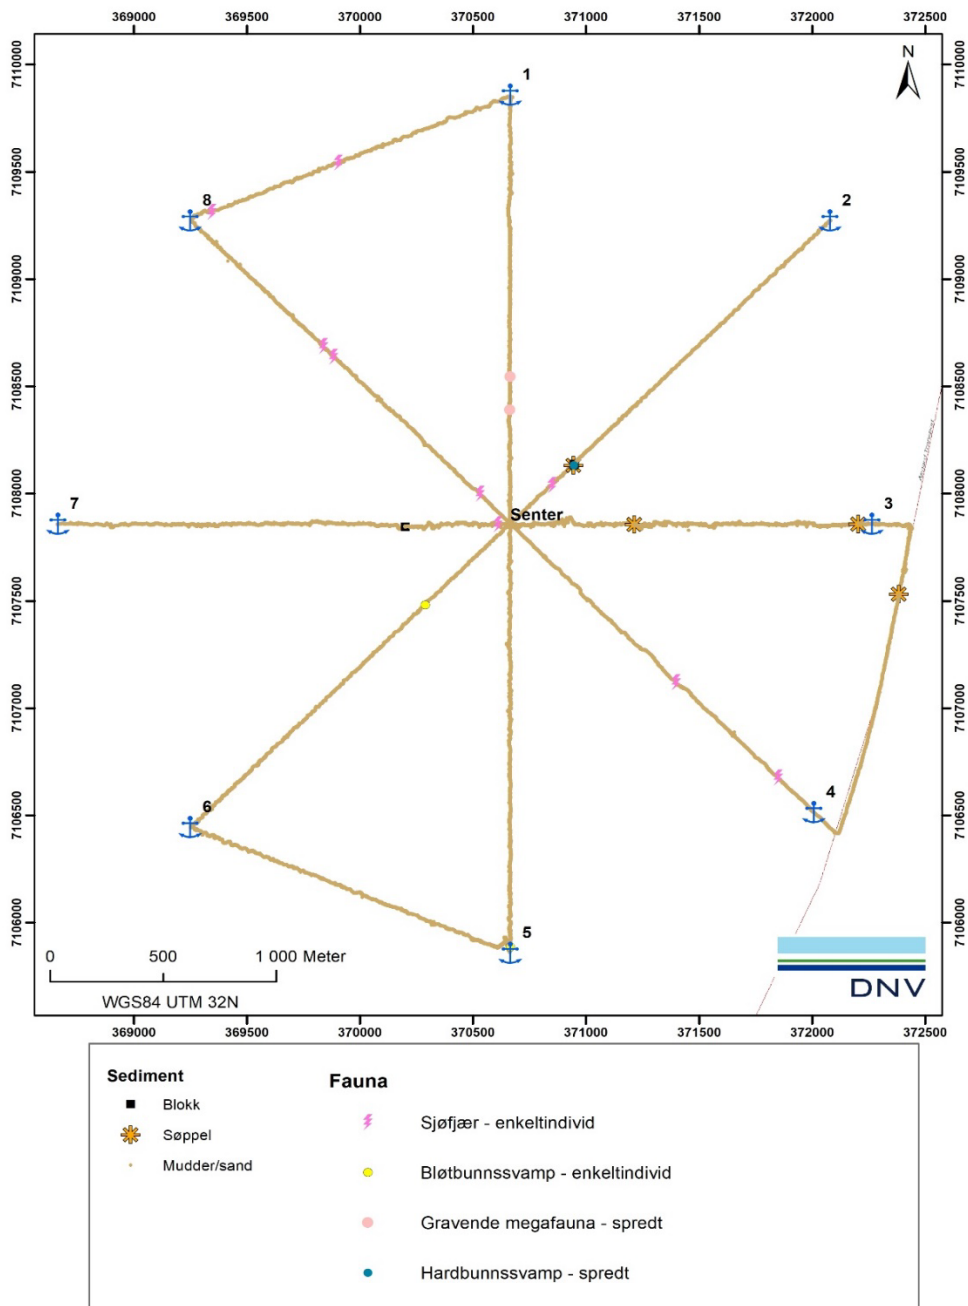
Figur 1. Kart over registreringer langs sjøbunnen, planlagt lokasjon for Smart Fish Farm.

Havbunnen ved lokasjonen var homogen, flat og ensformet og bestod til mesteparten av sand/mudderbunn med noen få områder med innslag av pukk og grus. Registreringer er vist i Figur 1. Dypet på lokasjonen var slakt skrånende og gikk fra omtrent 325 m i øst til 367 m i vest. Ved senterlokasjonen var det rundt 352 meters dybde.

Observert bentisk megafauna var dominert av suspensjons-eterer som sjøpølser, anemoner og sjøfjær, samt gravende krepsdyr og kråkeboller. Det ble ikke observert noen habitater som er klassifisert som sårbare av OSPAR eller Norsk rødliste for naturtyper. Det ble heller ikke observert noen arter som er vurdert som truet eller nær truet på Norsk rødliste for arter (Tabell 1).

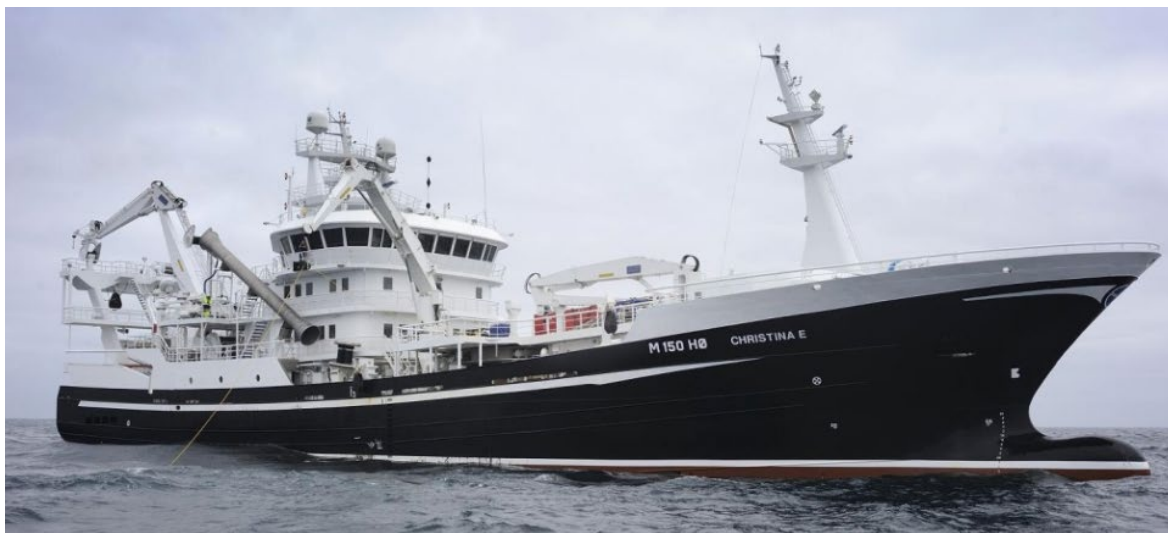
Figur 5. Fartøy brukt under undersøkelsen, «M/S Christina E» (fra www.erviksaevik.no/)

De visuelle undersøkelsene ble utført fra ankerleggingsfartøyet «M/S Christina E» i forbindelse med utsettelse av strømmålere og sediment prøvetaking (Figur 5). Undersøkelsen ble gjennomført i perioden 9. til 14. april 2021 og er videre beskrevet i toktrapport (DNV, 2021).

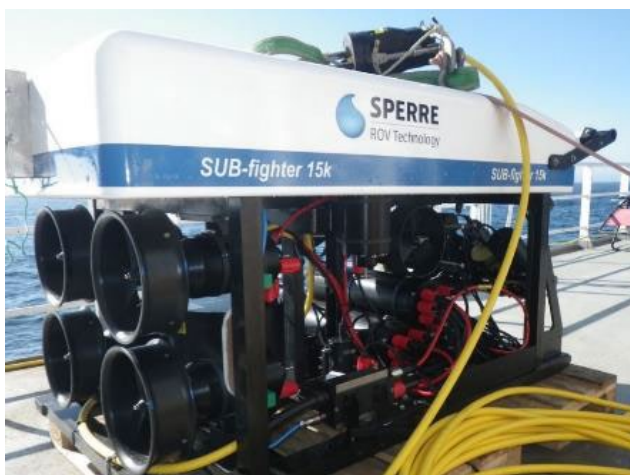
Figur 7. ROV brukt under toktet, en Sperre SUB fighter 15k

For visuell kartlegging av bunnforholdene langs planlagte ankerlinjer, ble DNV sin ROV, «Chimaera» benyttet (Figur 6). Beskrivelse og spesifikasjoner på ROV er gitt i Vedlegg C. ROV var utstyrt med videokamera (fremover og nedover) og høyoppløselig stillbildekamera med blitz. ROV var i tillegg utstyrt med en fremoverrettet sonar som detekterer gjenstander på sjøbunn, ut til 50 m til hver side. En transponder som kommuniserte med båtens Hipap transducer system var montert på ROV. Dette sikret en posisjonsnøyaktighet på <math>< 3\text{ m} \pm 5\%</math>. Oppsett og registrering av posisjonsdata ble utført av Fugro og lagret i en navigasjonslogg samt videre beskrevet i egen posisjoneringsrapport (Vedlegg E). ROV-operasjoner, observasjoner og logging av disse ble utført i en spesialinnredet container som er tilrettelagt for dette (Figur 7).

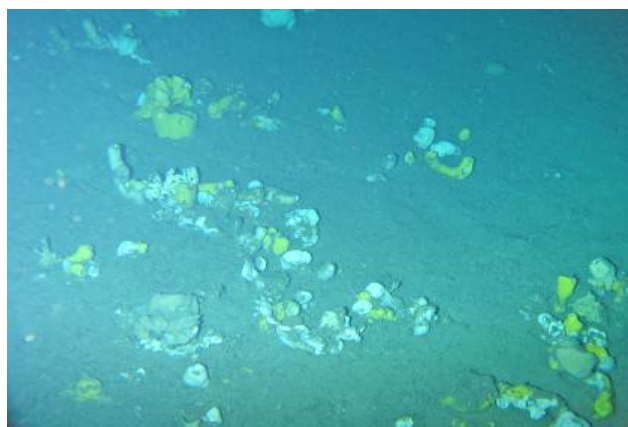
Bløtbunssvamp

Figur 8. Hovedkategorisering av svamptilfunn under visuelle undersøkelser.

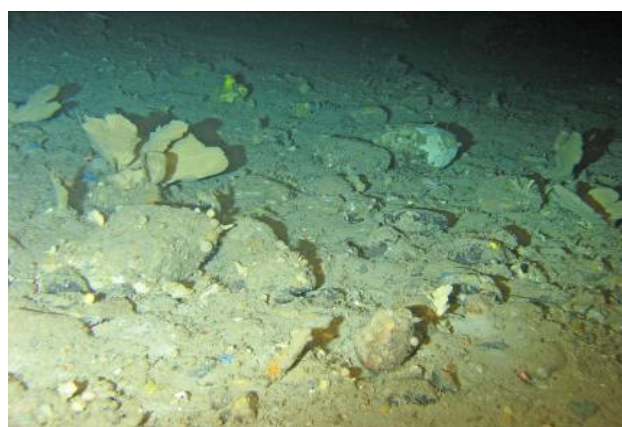
Hardbunssvamp

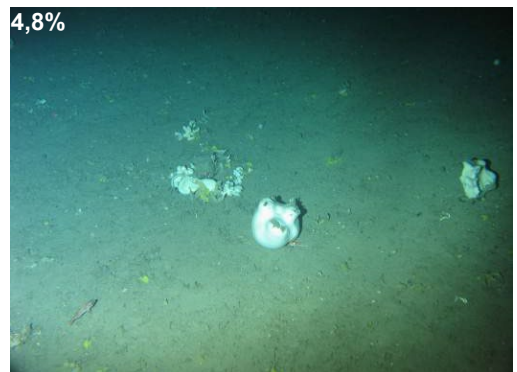
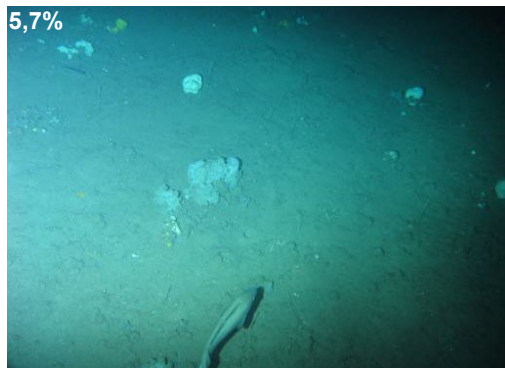
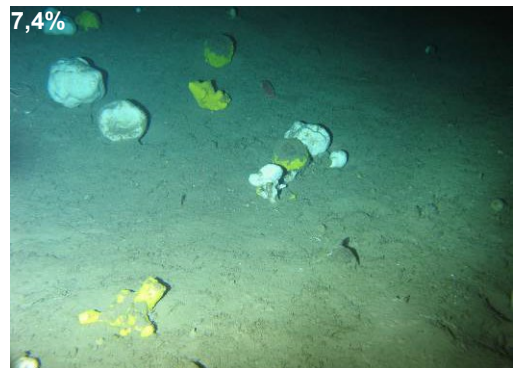
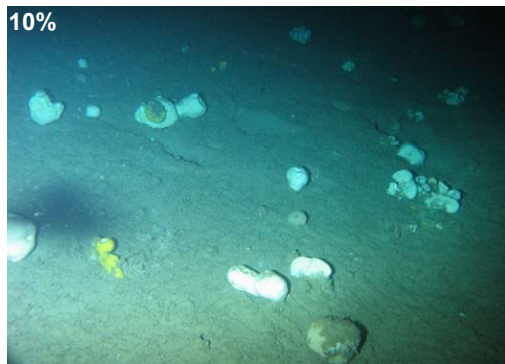
Figur 9. Eksempelbilder på de ulike tetthetskategoriene med dekningsgrad (%)

Vanlig (~5-10% dekningsgrad)

Høy >~10% dekningsgrad

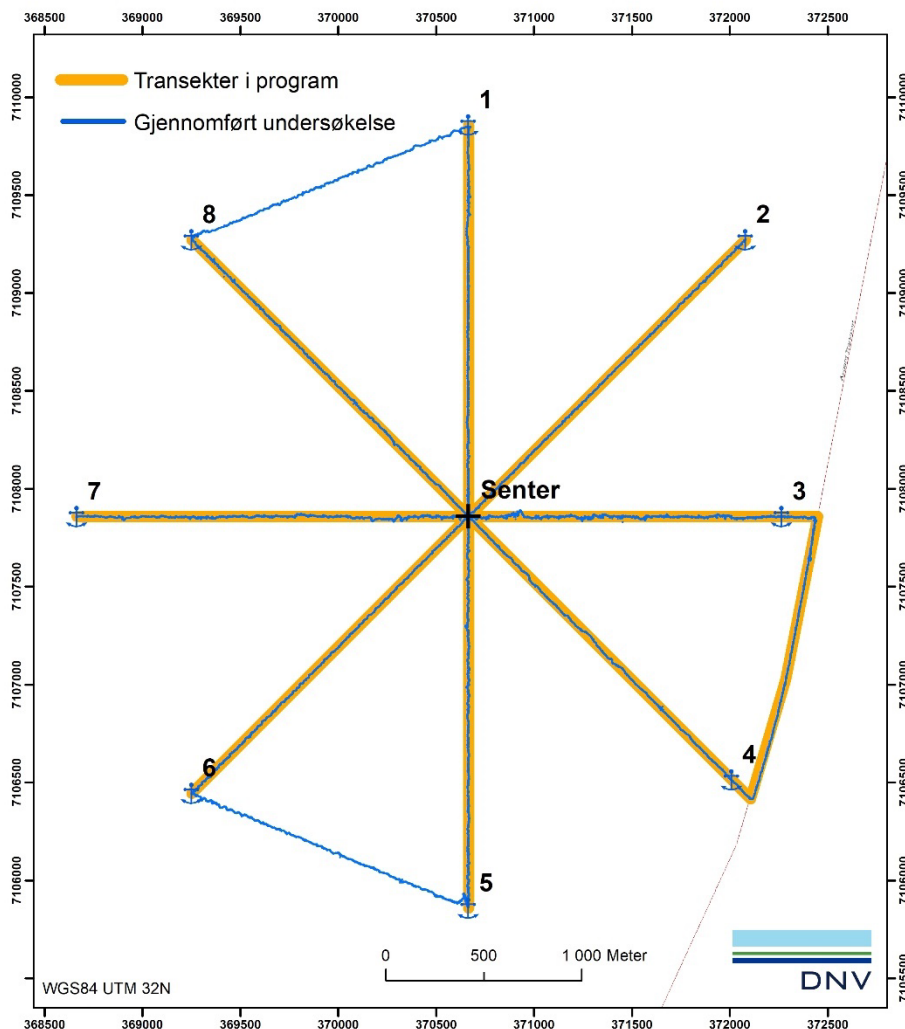
Figur 10. Planlagte linjer i gult og reell kartlegging i blått.

Totalt ble det fløyet ca. 20,3 km fordelt på 1 dykk og det ble produsert ~25 timer med opptak langs havbunnen (detaljer er vist i Tabell 5 og Figur 10). Det ble totalt tatt 656 stillbilder. Undersøkelse av nærliggende Åsgard Transport rørgate ble utført. Plassering stemmer relativt godt med opplysninger fra OD, men det var mindre avvik (se avsnitt 4.3).

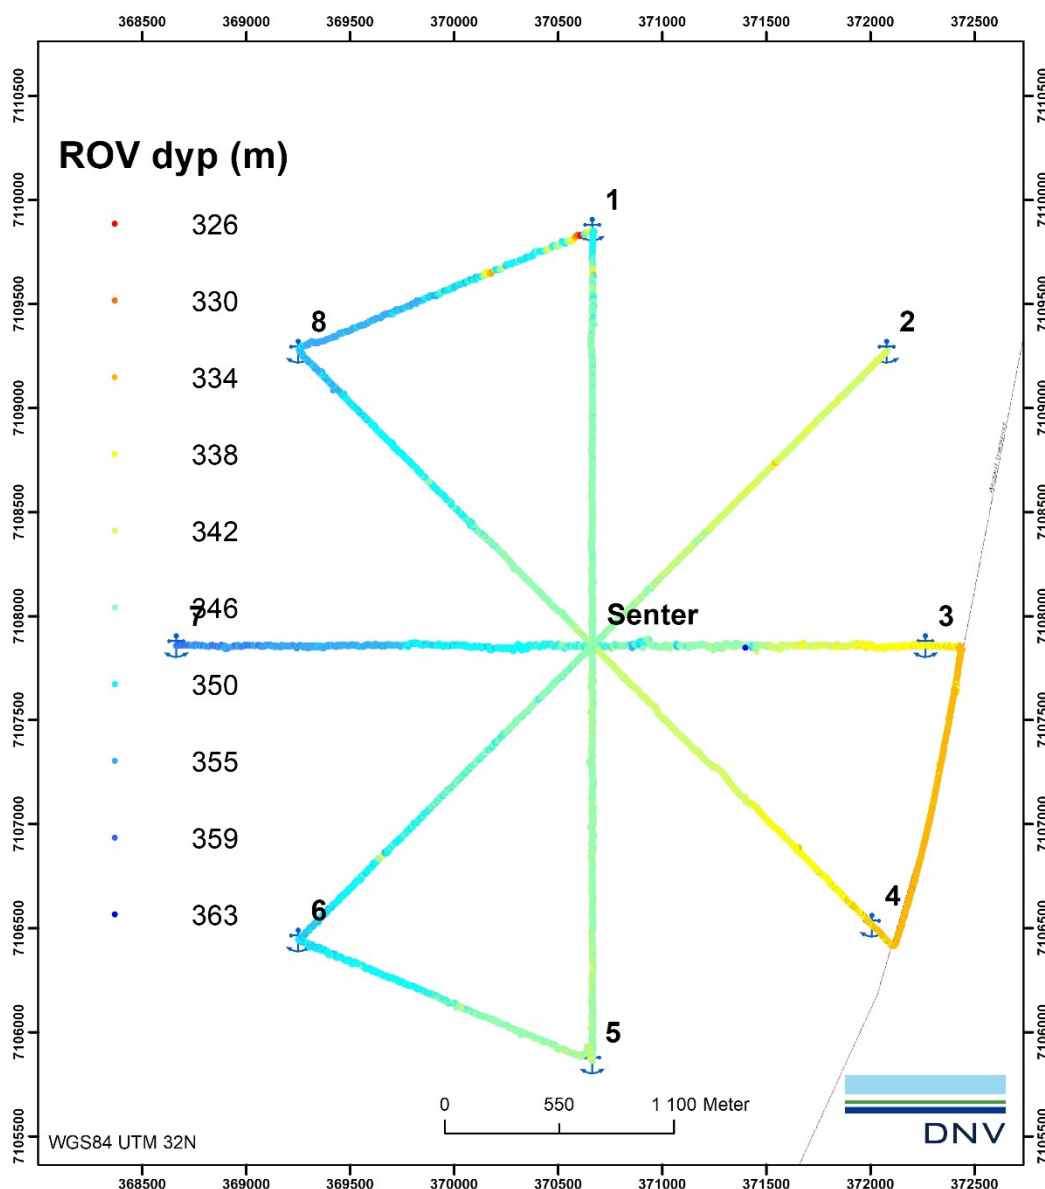
Figur 11 Registrert dybde (målt fra ROV) på planlagt lokasjon for Smart Fish Farm.

Havbunnen ved lokasjonen var homogen, flat og ensformet. Dypet på lokasjonen var slakt skrånende og gikk fra omtrent 325 m i øst til 367m i vest. Ved senterlokasjonen var det rundt 352 meters dybde (Figur 11 og Figur 12). Gjennomsnittsdypet fra ROV loggingene var 348 meter. Sedimentet bestod nesten utelukkende av mudder og sand (99,9 % av registreringene) med noen få innslag av steinblokker. Spor av menneskelig aktivitet ble observert i form av 5 registreringer av søppel og ett trålspor. Det indikerer at området er lite utsatt for bunntåling, til sammenligning ble det fra 62 undersøkelser i Barentshavet, mellom 2006-2014 i gjennomsnitt observert 1,5 trålspor per 100m (DNV GL, 2017). Sammenstilling av registreringer er presentert i Tabell 6 og eksempelbilder er vist i Figur 13 og Figur 14.

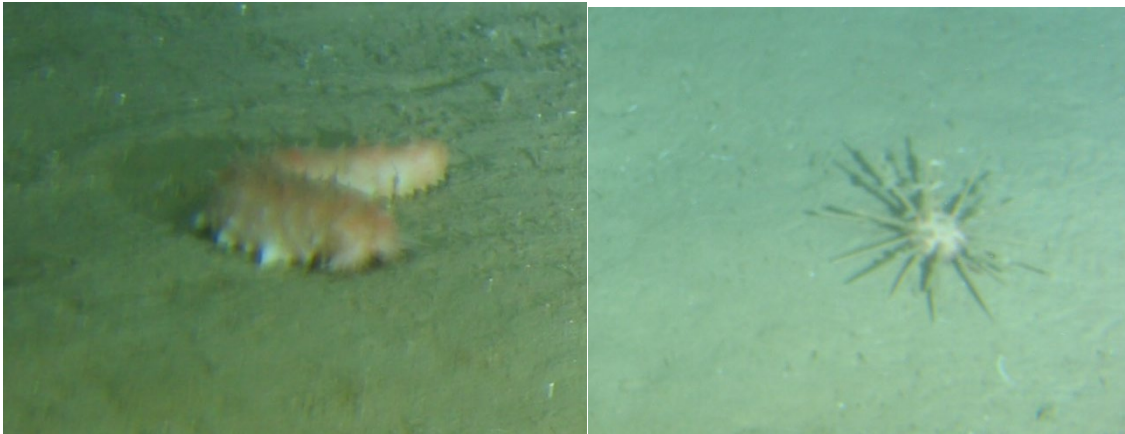
Figur 18 Dominerende pigghuder i undersøkelsen V: Rødpølse (*Parastichopus tremulus*), H: Sjøpinnsvinkonge (*Cidaris cidaris*)

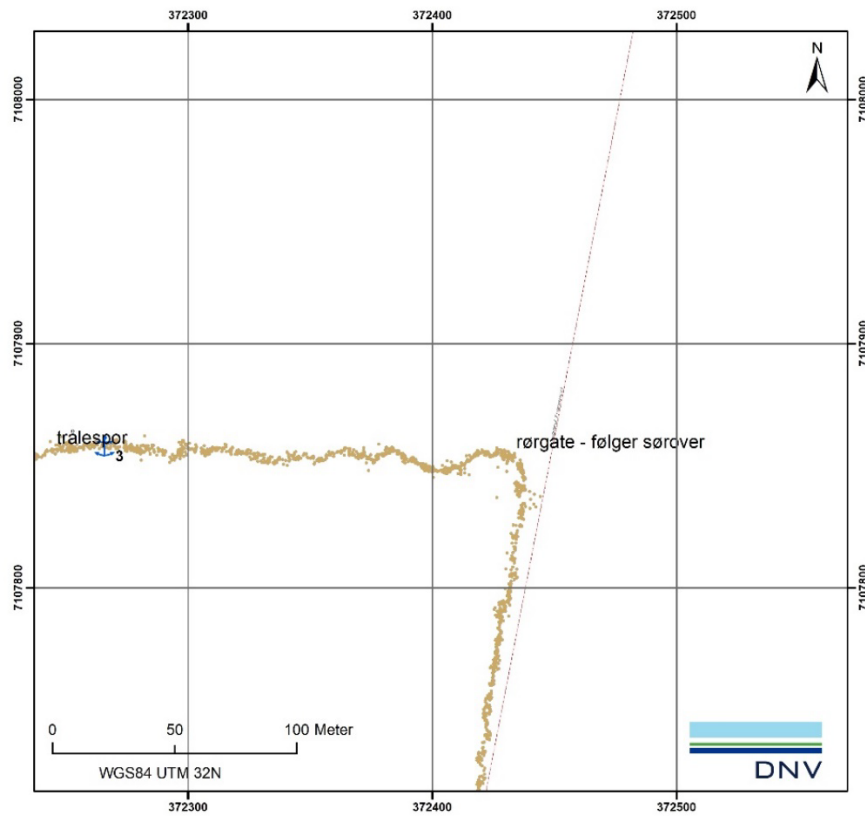
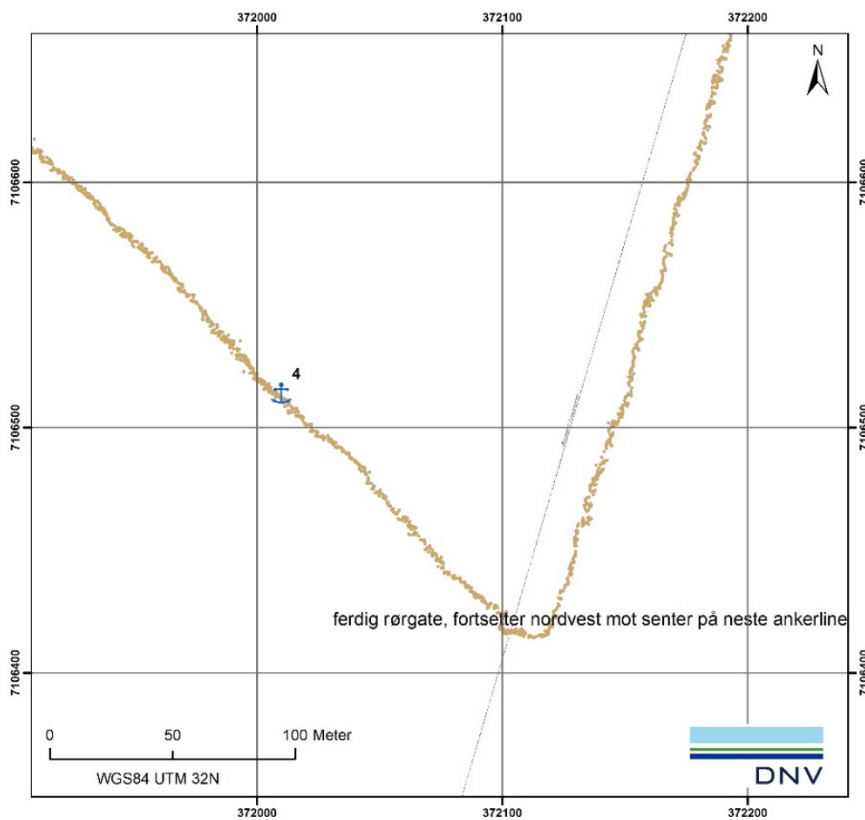
Anker 3 og 4 ligger henholdsvis 170 og 130 meter unna Åsgard transport rørgate. Rørgaten ble filmet mens ROV forflyttet seg mellom anker 3 og 4 (over et strekk på ~1,45 km). Det er mindre avvik fra plassering oppgitt av OD: 9 meter ved anker 3 (vestover) og 15 meter ved anker 4 (østover). Eksempelbilde er gitt i Figur 19. Kart med detaljer er gitt i Figur 20.

Figur 20 Kart med detaljer anker 3 (øverst) og anker 4 (nederst) I forhold til rørgate. Oppgitt posisjon I henhold til OD data vist som rød linje, ROV spor mens rørgate ble fulgt er vist som brune punkter.

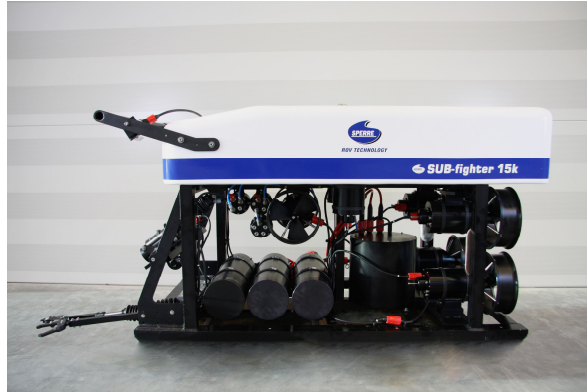
SUB-fighter 15k

Vehicle	LWH 162 x 90 x 96 cm
Frame	Anodized aluminum
Housings	3 x 1 ata.
Weight in air	550 kg approx.
Payload	20 kg approx.
Max depth	700 m.
Buoyancy	Solid cell structure
Power input, TBA	230 / 400 / 440 / 690 VAC, 3 phase 15 kW
Thrusters	7 thrusters, Horizontal 5 x 2000W, Vertical 2 x 2000 W,
Speed approx.	Horizontal 3,5 knot, Vertical 1.9 knot Lateral 1,8 knot, Turn 60 deg/sec
Pan /Tilt	Pan 45 degrees, Tilt 90 degrees
Camera interfaces	4 off, 2-3 x simultaneous video channels
Camera 1, standard	Low light color camera, PAL 540 TV lines 0,05 lux
Camera 2, option	Low light black and white, PAL 570 TV lines 0,0001 lux.
Camera 3, option	Zoom camera, Colour CCD, HD block, PAL, 510 TV lines, 1,5 lux, 18 x optical 4 x digital zoom
Light interfaces	6 off, total 1500 W
Lights, standard	2 x ROS Q-LED III, 3500lux (500 W halogen equivalent)

Sensors	300 bar depth sensor Fluxgate compass Moist sensors
Auto functions	Auto depth, Auto heading, Auto altitude (option)
Multiplexer fiber, telemetry	Focal 907 standard fiber optical multiplexer 3 x 8 bit or 2 x 10 bit video channels, 6 x RS 232/485 Optional: HD-video, Ethernet, USB link, others
Survey channels and interfaces, TBA	Sonar, 1 x RS 485, 24 VDC (standard) Transponder power 24 V DC (standard) Video, 4 off (standard) Lights, 6 off (standard) Actuator, 2 off (standard) Survey channels, 1 x RS 232, 1 X RS 485, 24 V (standard) Thruster or AC tool (option)

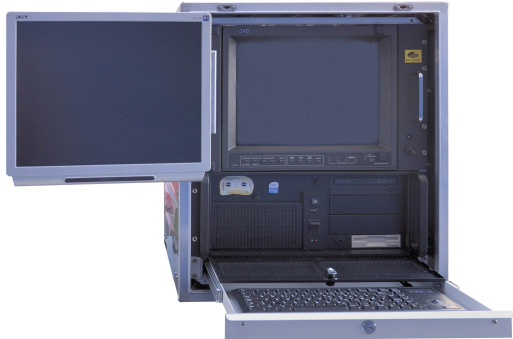
RACK	
Aluminum splash proof cabinet 19', 12 U

Video monitor	
Data monitor	
Key pad and roller ball in drawer	
PC with DVD and HDD video recorder	
Overlay and video software	
Software for MS 1000 sonar	
Fiber multiplexer	
Connections for fiber, data and video	
L x W x H, 60 x 54 x 64 cm	
Weight. 50 - 72 kg. depending on model
